A new look at the explosion that caused the Sultana disaster

Hartford Steam Boiler

May 2015

Patrick Jennings
Principal Engineer

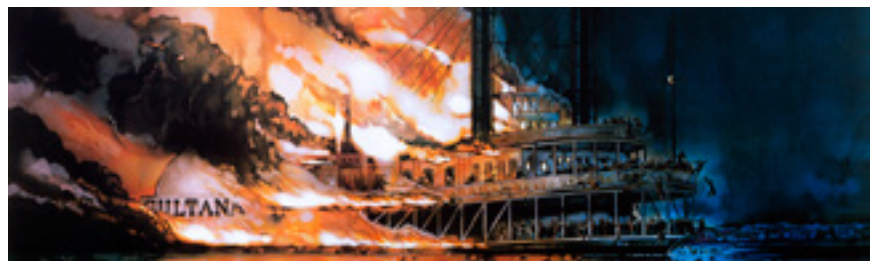
Figure 1 - The Sultana burning

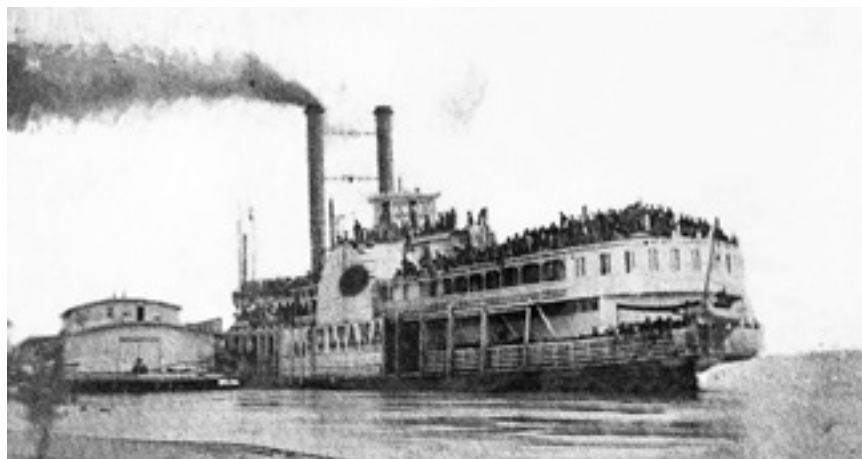
The prosecution at the trial of Captain Frederic Speed asked multiple questions regarding the careening of the boat. Due to the large number of troops on board and the small amount of cargo in the hold, the boat did rock when many men rushed to one side, most notably during the last picture taken of the Sultana in Helena Arkansas, shown in Figure 3.

Figure 3 - Sultana at Helena Arkansas

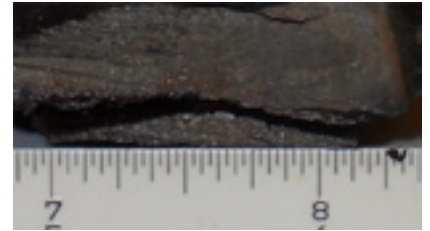
CH 1 is a wrought iron that is heated and wrought (or worked) with charcoal to increase the carbon content, which increases material hardness. The process of making charcoal hammered iron leaves imperfections that weaken the iron plates (Figure 4). These are seen as black lines in the plate. Based on the construction techniques of the time, there would have been inclusions and imperfections in the iron used in the boilers, as well as poor control of other elements such as sulfur. In addition to weakening the plates, the inclusions and imperfections can be locations for corrosion to occur. While the material may look acceptable on the surface, it is often weakened due to the inclusions. Very often, the inclusions in iron can reach the surface and allow corrosion to occur in the interior of the iron as shown in Figure 5. In this wrought iron sample illustrated, the inclusions led to a complete separation near the surface as well as corrosion in the interior of the plate. We do not know the extent of corrosion of the Sultana boilers were, but some level of corrosion is probable.

Figure 5 - Wrought iron plate with internal corrosion and separation

The iron used in the Sultana boilers contained inclusions, likely had some level of corrosion and became brittle when heated and cooled repeatedly. The boilers did experience overheating on a regular basis and while overheating was often blamed on low water, the cause of overheating was due to mud and other impurities collecting on the boiler parts. These boilers used make-up water straight from the Mississippi river, which was the source of this sediment.

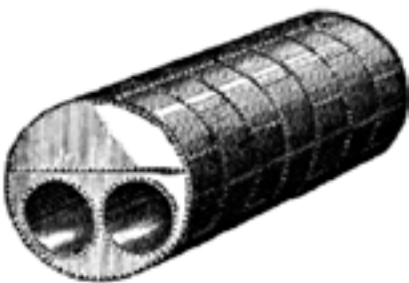
The standard boiler installed on steamboats was a dual flue boiler set into a casing above the firebox. In a typical design, the boilers were arranged in a battery of 3-4 boilers located side by side on the boiler deck. The fires were under the front of the boiler and the flames and heat traveled underneath along the shell bottom. At the rear, the combustion gases turned and entered the dual flues transferring heat to the water in the boiler. This two-flue design provided sufficient space inside the boiler to remove sediment and scale, and supported circulation to keep the sediment in suspension and allow it to be blown out through the mud drum.

Figure 8 - Double Flue Boiler

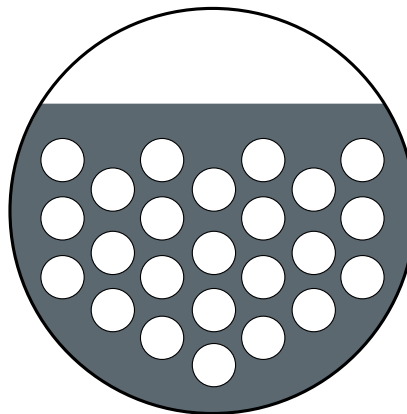
The Sultana had four fire-tube boilers, each 46" in diameter and 18' long. In a firetube boiler, instead of two large flues, the boilers had 24 flues (tubes) each 5" in diameter arranged in a staggered arrangement that carried the gases through the boiler. This larger number of smaller tubes increases the surface area between the hot gases and the water, significantly improving both boiler efficiency and capacity. With this design, the spacing between tubes or between the tubes and the bottom would have been very tight, as indicated in Figure 9.

Figure 9 - Firetube boiler layout

While the design is more efficient, it significantly worsened the sediment problem. The number, location and close spacing of the tubes made it difficult to clean the boiler. In addition, during cleaning, the condition inside the boiler would have been hard to see. J.J. Witzig, the Supervising Inspector of the Fourth District, noted this after the the Sultana disaster. This boiler design was not suited to the harsh conditions of the Mississippi, and both Nathan Wintringer and Charles Lyda noted that the tubular boiler design was "done away with" from operation in steamboats and
